Manhole Inspection Summary

Manhole # S06II2024MH

Insp Date: **10/10/06 1:44 PM**

Location Address: **7320 WALLIS AVE**

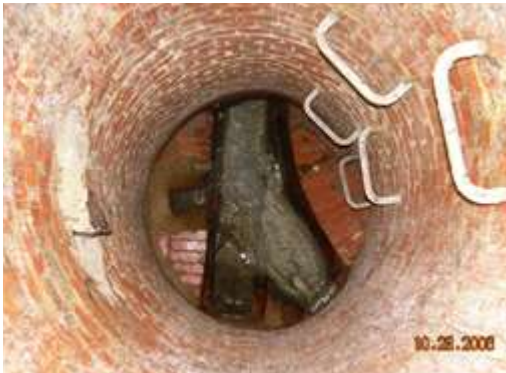
Top View

Infiltration: ☐ None ☒ **Joint** ☐ Cracks ☒ **Mortar** ☐ Roots ☐ Wall

Count: **7** Missing: **0** ☒ **Corroded**

Adjustment, Corbel and Barrel infiltration.
Corroded steps.

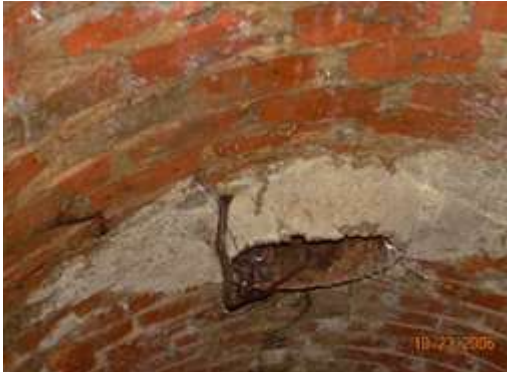
Defect

Condition: ☐ Sound ☐ Cracked ☒ **Root Intrusion** ☐ Loose Brick ☐ Deteriorated

Infiltration: ☐ None ☐ Joint ☐ Cracks ☒ **Mortar** ☒ **Roots** ☒ **Wall**

Corbel root intrusion and infiltration.

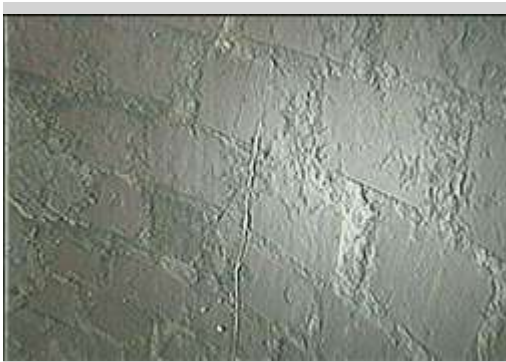
Defect

Condition: ☐ Sound ☐ Cracked ☒ **Root Intrusion** ☐ Loose Brick ☐ Deteriorated

Infiltration: ☐ None ☐ Joint ☐ Cracks ☒ **Mortar** ☒ **Roots** ☒ **Wall**

Barrel root intrusion and infiltration.

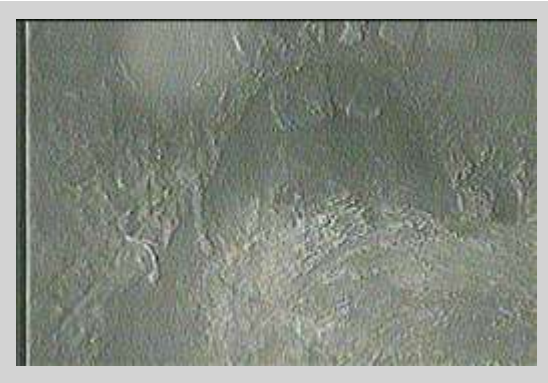
12 in. Circular Gravity Sewer Pipe Out @ 12 O'Clock

Channel root intrusion.

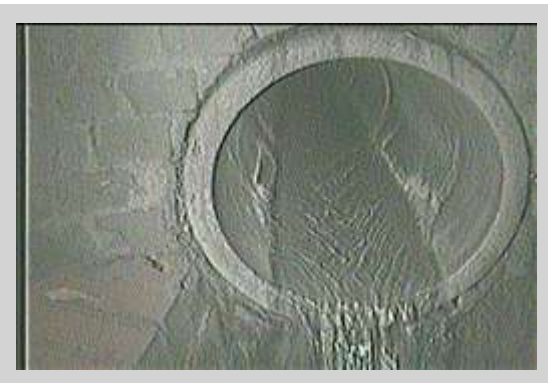
15 in. Circular Gravity Sewer Pipe In @ 4 O'Clock

Infiltration: **Evidence** Pipe Seal Cond: **Unknown**

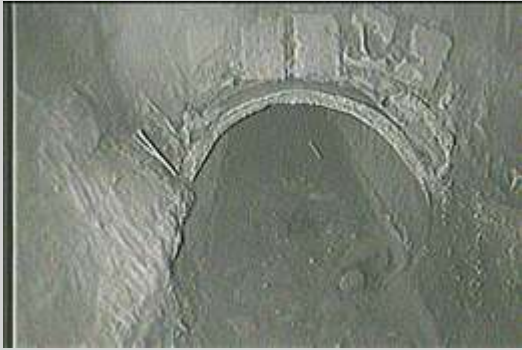
10 in. Circular Gravity Sewer

Deposits: ☐ None ☒ **Mud** ☐ Sludge ☒ **Debris** ☐ Grease

Deposits Extent: **Light**

Infiltration: **Evidence**

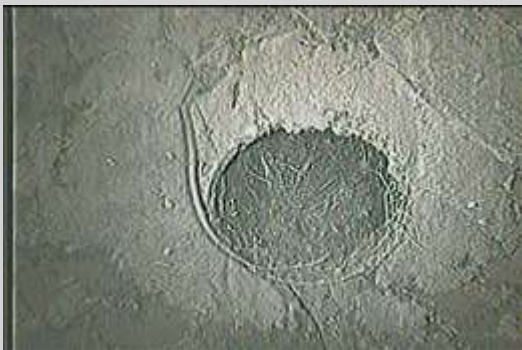
Pipe In @ 9 O'Clock

Comments **The I4 pipe seal is not flush to the pipe. The I9 pipe picture shows grease deposits inside of the pipe. The I9 pipe in has root intrusion inside of the pipe.**

Deposits: ☐ None ☐ Mud ☐ Sludge ☐ Debris ☒ **Grease**

Infiltration: **Evidence**
